N72/L5331 Junction, Spa Glen, Ballyvinitier,
Mallow, Co. Cork

STAGE 1 & 2 ROAD SAFETY AUDIT

February 2024

MHL & Associates Ltd.
Consulting Engineers

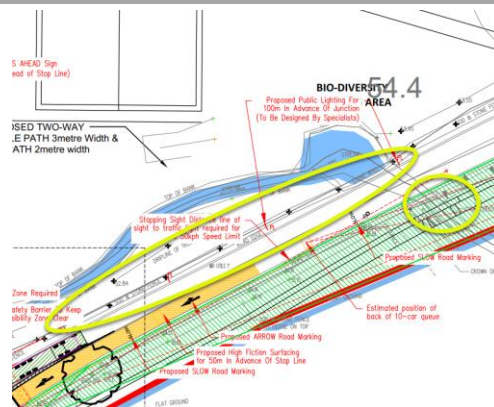
Whilst a safety barrier protects errant vehicles from collisions with roadside lighting columns at the junction, a number of the public lighting columns appear to be located along the roadside without any protection. Also the removal of the road edge in the vicinity of the existing culvert to the east of the junction may present a hazard to motorists. Failure to provide a forgiving roadside, clear of hazards, may lead to collisions between errant vehicles and public lighting columns or culvert/bridge parapets.

Ensure that any the road edge and any roadside hazards are removed or designed appropriate to the location to ensure the delivery of a Forgiving Roadside at the location, in accordance with relevant design standards.

2.5	Yes	Yes	Public lighting columns will be protected from errant vehicles. It is not intended to remove the stone culvert parapet, but additional safety barrier may be provided at this location as required.

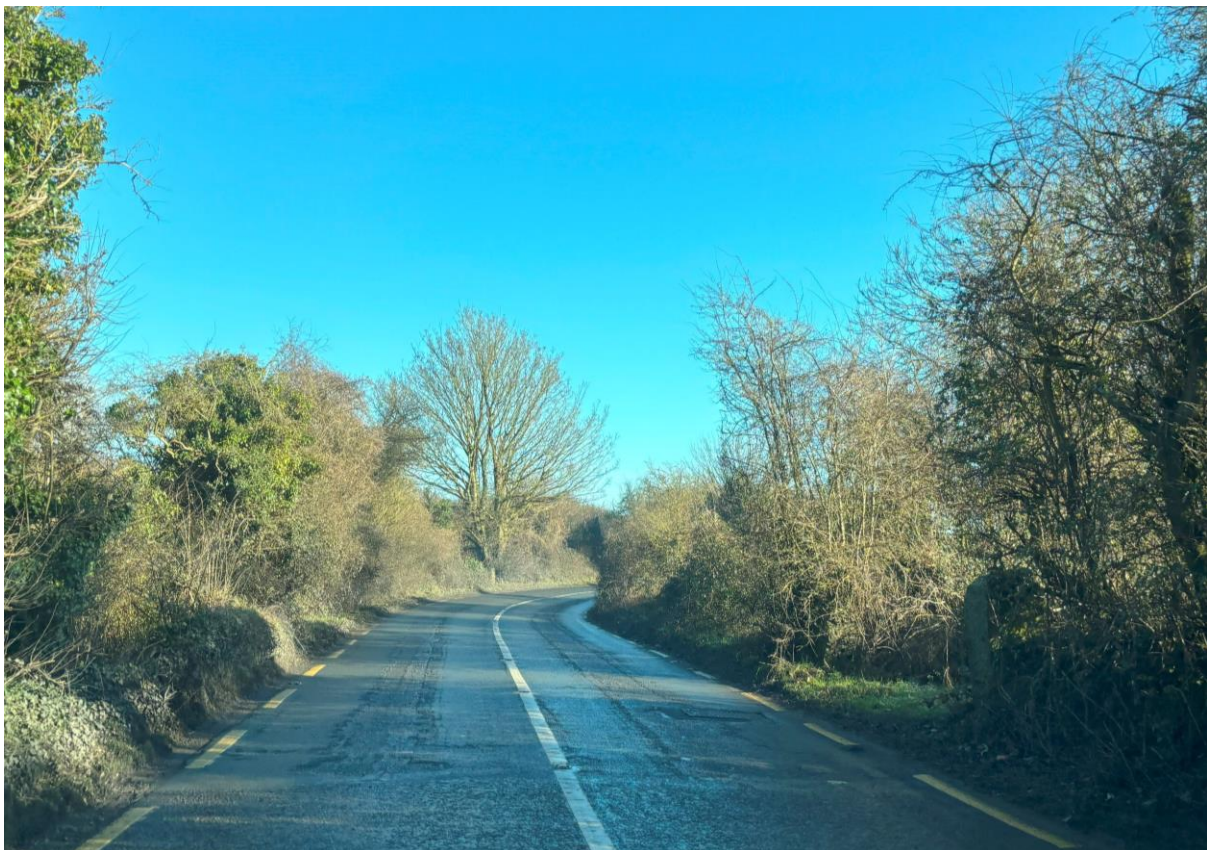
The N72 road surface condition is very poor on approach to the junction, from the Fermoy side. See photos 6 and 7 in Appendix A. Such poor road surfaces can lead to vehicles losing control and colliding with the road edge.

Photo 6 N72 beyond the junction coming from Mallow town centre
(Looking north-eastwards)

Resurface the road as necessary in accordance with relevant design standards and best practice.

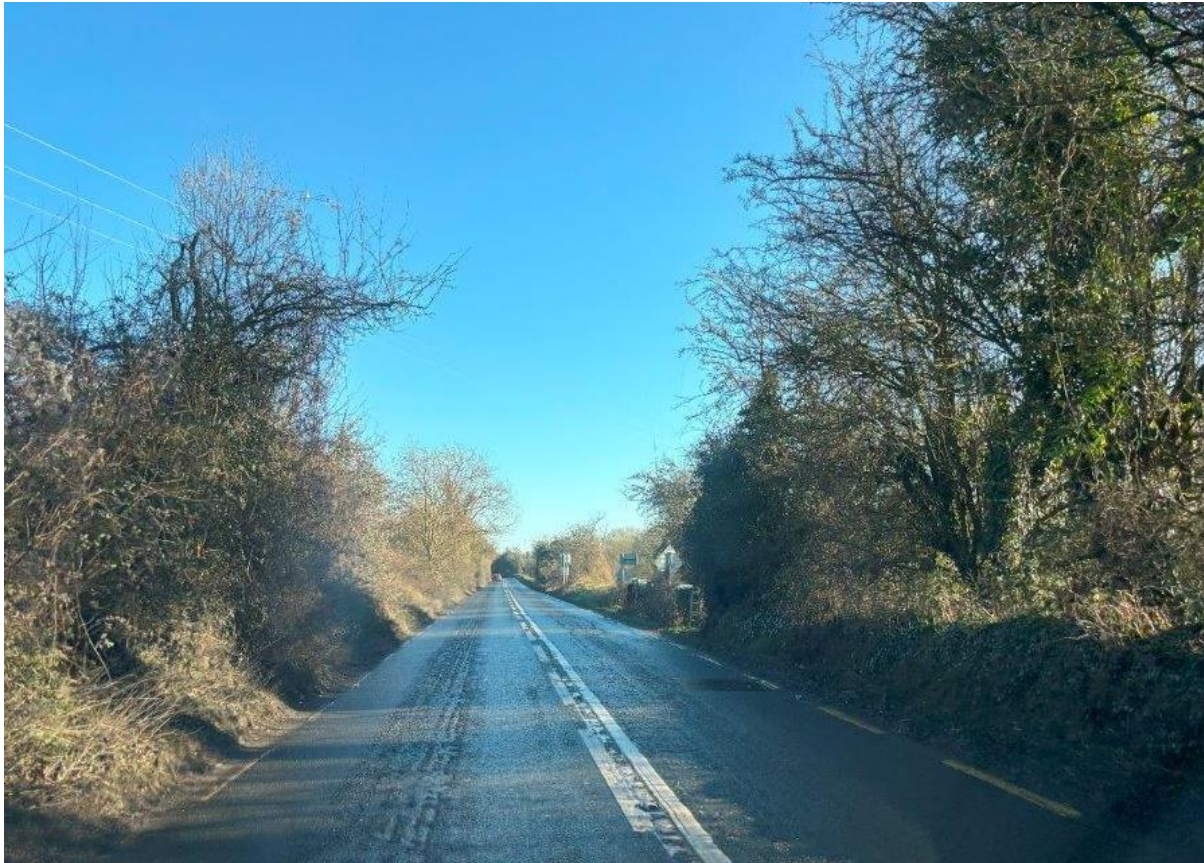
Photo 7 N72 beyond the junction coming from Mallow town centre (Looking north-eastwards)

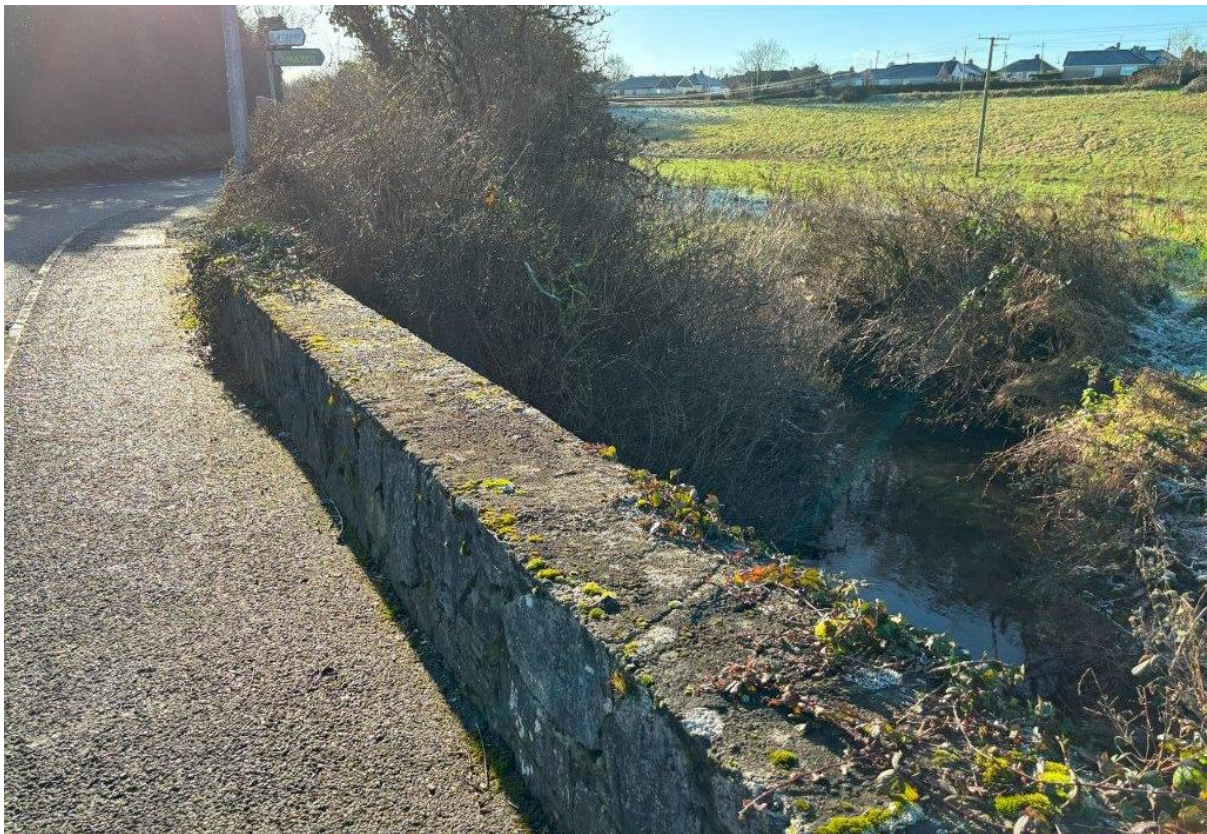
Whilst the required intervisibility zone is identified at the junction it appears to encompass the existing bridge parapet wall and the proposed "low safety barrier". Failure to provide the required envelope of visibility within the intervisibility zone may lead to head on collisions as a result of drivers entering the junction and not observing a conflicting vehicle movement. See photos 10 and 11 in Appendix A.

Photo 10 Existing bridge/culvert Parapet wall on the L5331 (looking southwards)

Ensure that adequate visibility is provided within the intervisibility zone at the junction in accordance with relevant design standards.

2.2	Yes	Yes	Minor obstructions to visibility caused by historical bridge parapet wall is unavoidable. This wall is 0.6m high and it is possible to see over and around the wall. The existing hedgerow and timber post and wire fence will be removed and a low safety barrier used along the low-level stream. All existing signs impacting negativity on inter-visibility will be relocated.

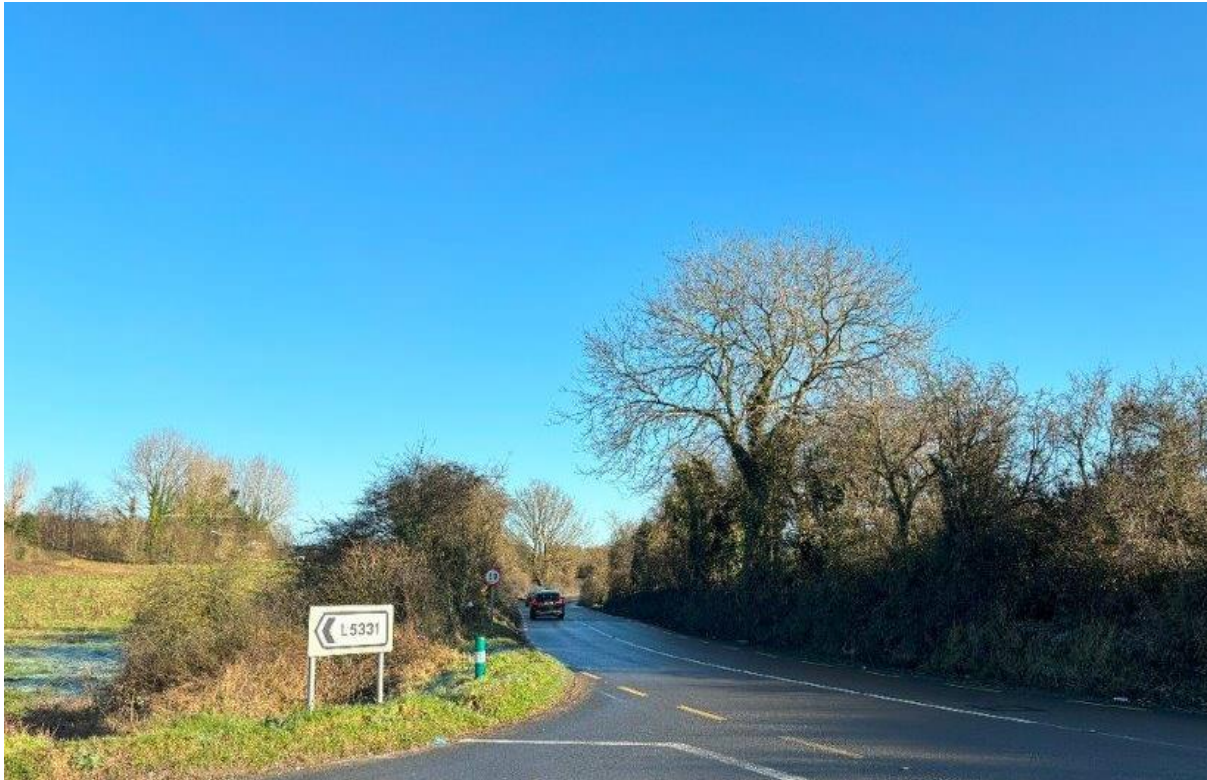
Photo 11 Visibility to the Left from the L5331 onto the N72 (looking eastwards)

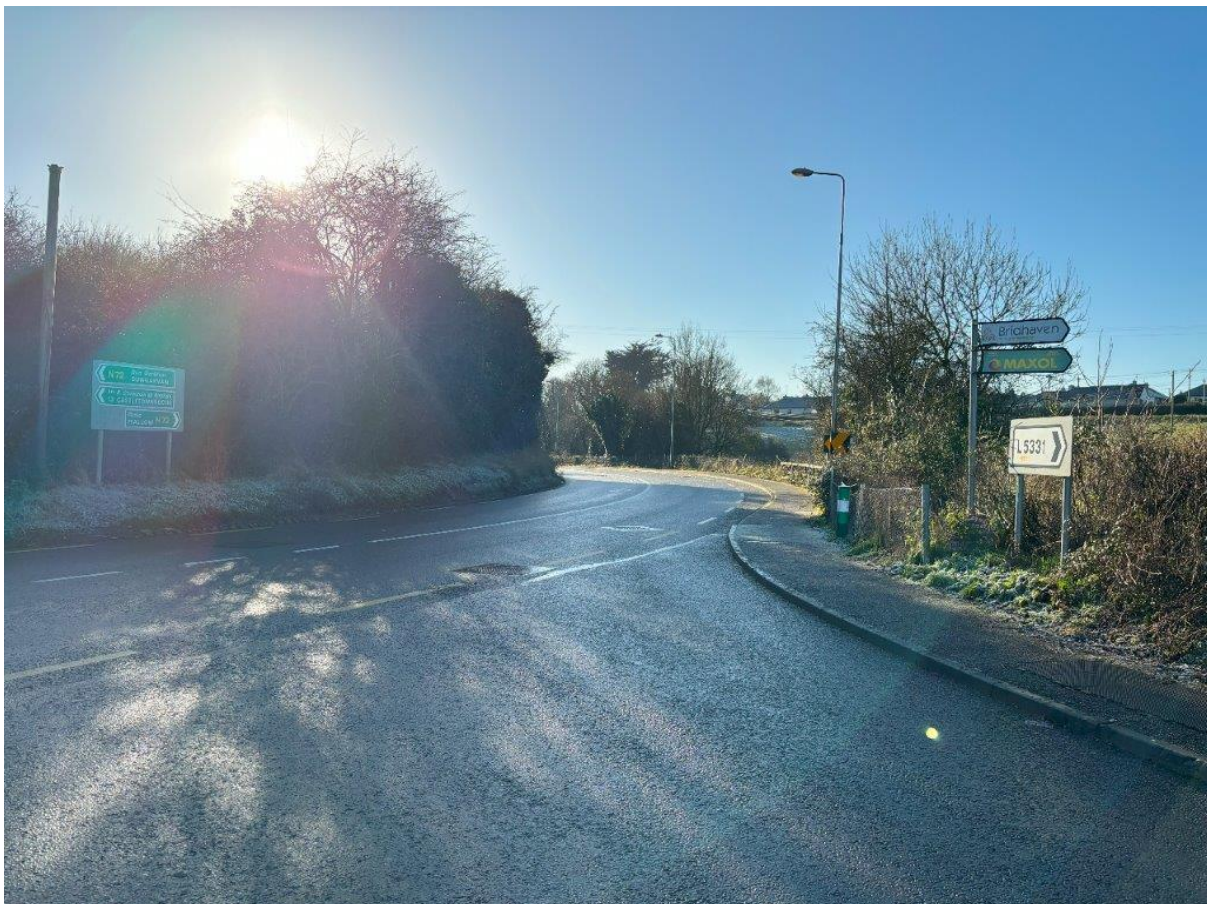
Photo 11 Visibility to the right from the L5331 onto the N72 (looking westwards)
